Supplemental Report by John W. Carson, Ph.D.

**Failure of a soybean meal silo supplied by Sioux Steel to Agropecuaria
el Avión plant in Tepic, Nayarit, Mexico**

Report 70622-2

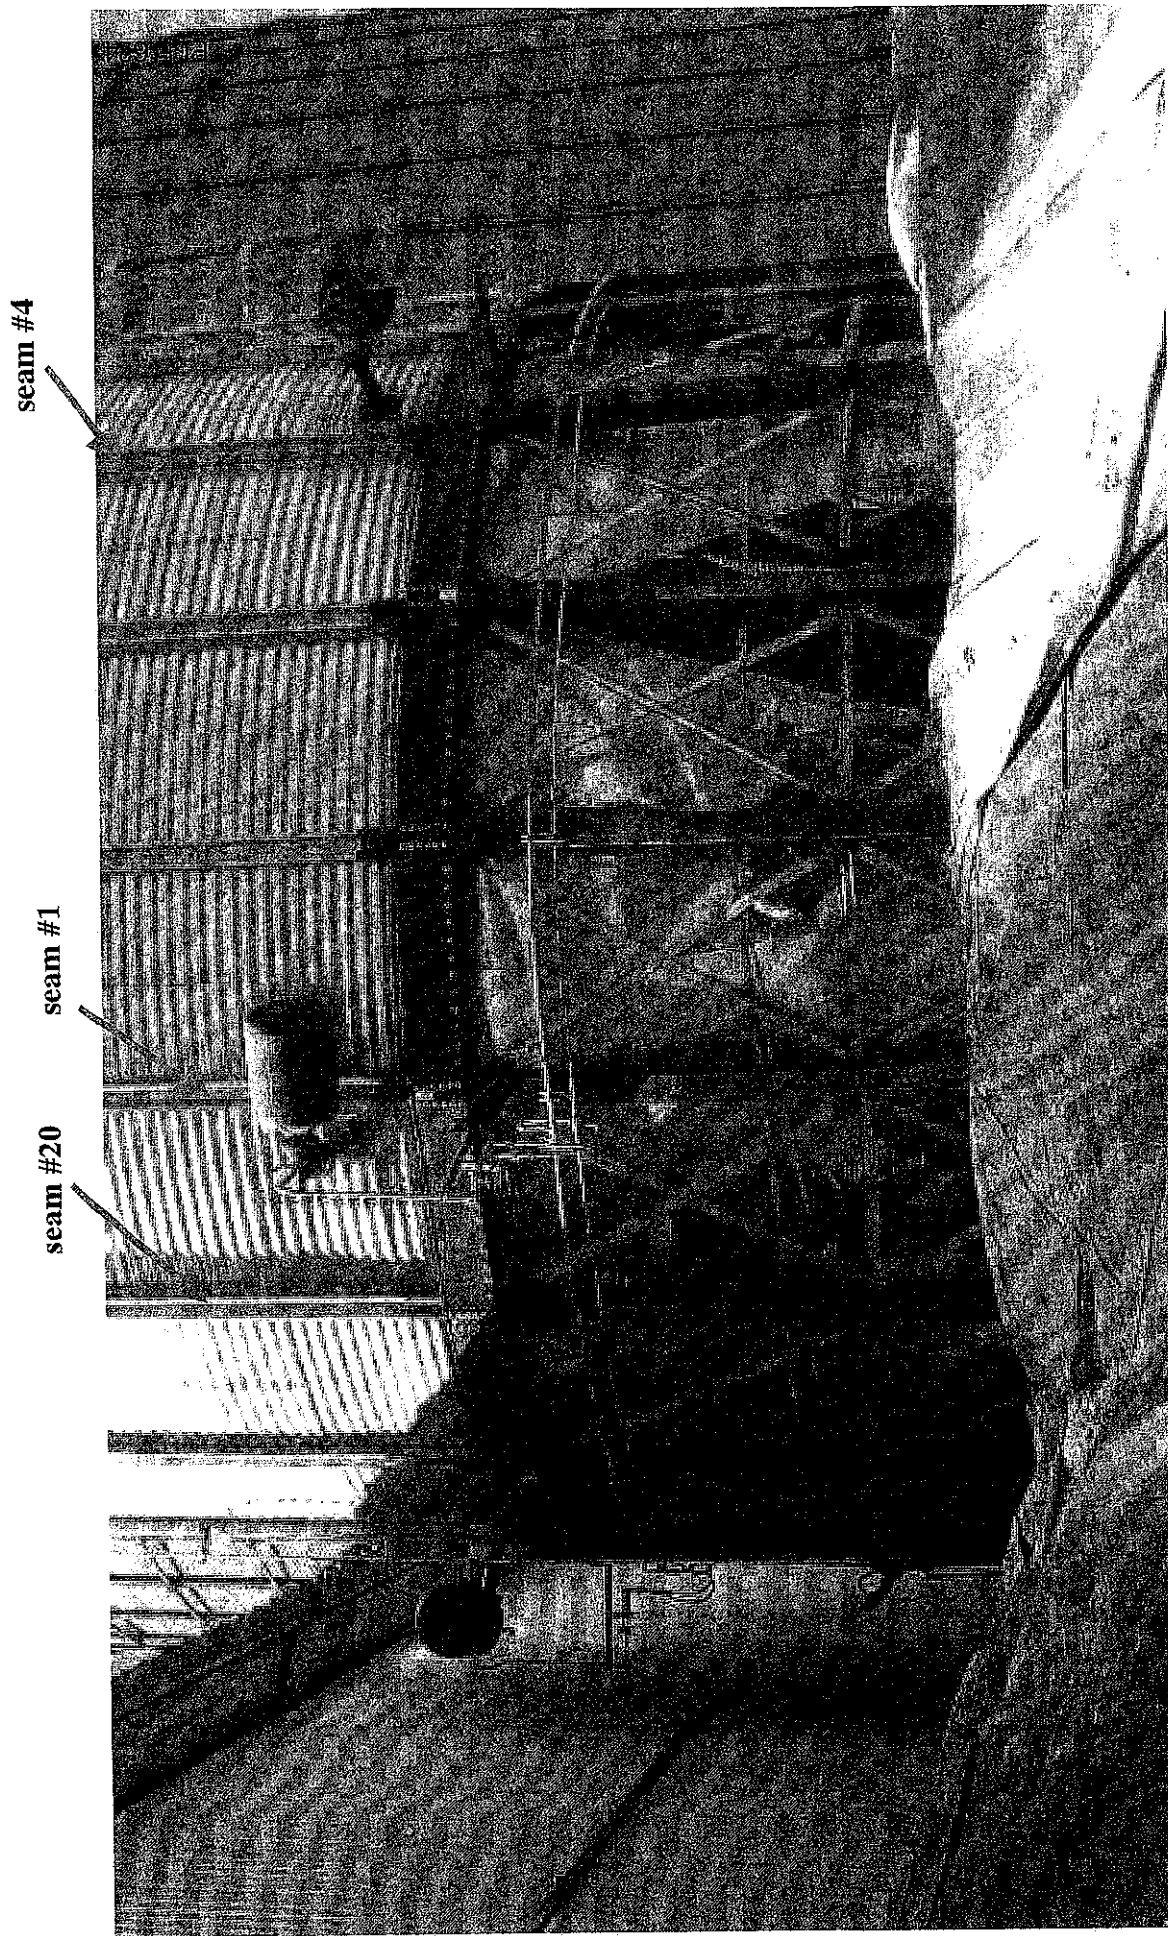
Fig. 1 Photo PLF 624

In reviewing the various photos of the silo after it failed I numbered the seams #1 through 20 starting with the seam adjacent to the cylinder air cannon on the northeast side as #1 and proceeding counterclockwise when looking down on the silo. Using this numbering scheme I was able to identify the first failed seam as seam #4 and the second as seam #20. See Figures 1 and 2.

1. The silo started to fail in the lower portion of one of the northwest hopper seams, most likely what I have denoted as seam #4. Within 0.04 sec. of the start of this failure the upper portion of this seam started to fail. This was followed by failure in the upper portion of one of the northeast seams, most likely what I have denoted as seam #20.

seam #4
